## April 2022 Case Study Proper Selection & Installation of a Superscrew Splice

Davis Industrial technicians recently completed emergency repairs for a customer who suffered catastrophic splice failure during after-hours production. According to the customer, this splice lasted a single revolution of the system. Our highly trained, 24/7 emergency team responded to the site and immediately began assessing the problem to develop a solution. After completing the repairs, the splice was returned to our shop for evaluation. Several factors were immediately observed which contributed to the complete failure and unnecessary downtime for this customer. While a highly reliable product, mechanical splices must be installed properly to gain the advantages of high strength and durability.

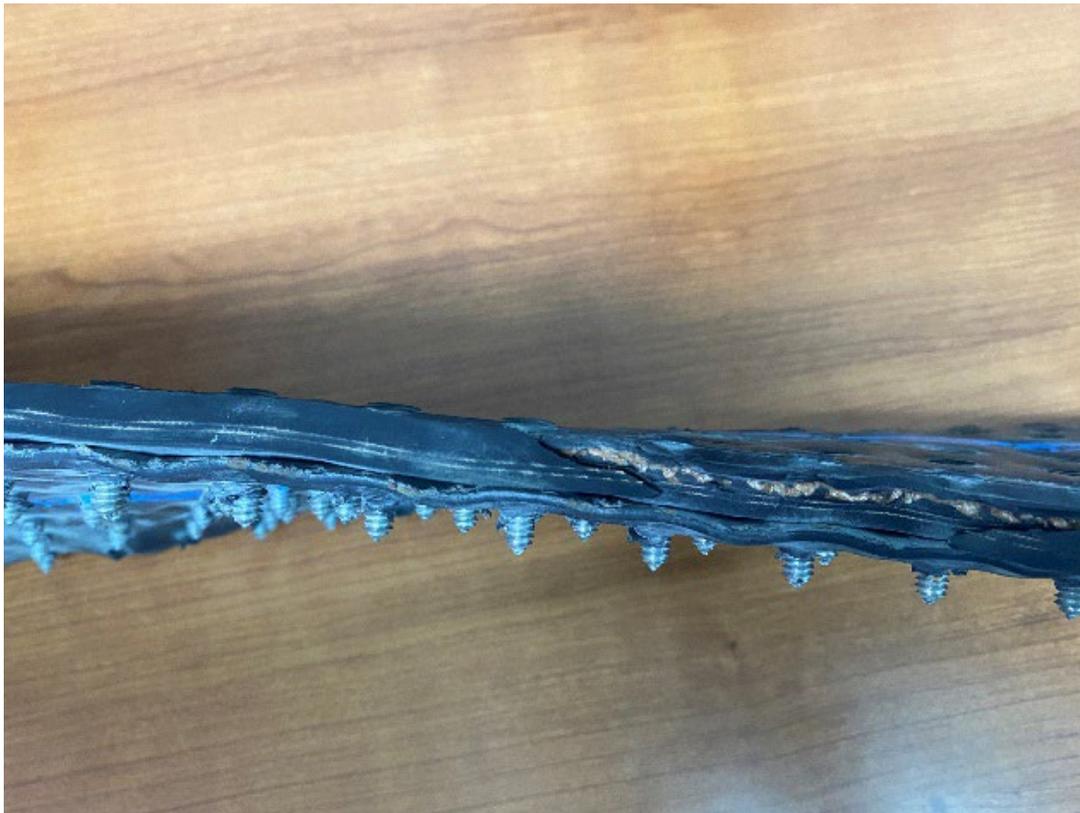
- Not skived properly.

It is imperative that skiving is done at the proper depth consistently across the application. This allows the splice to sit flush with the top cover of the belt, which reduces contact with belt cleaner systems, preventing excessive wear to the splice. In this case, the skiving was done inconsistently resulting in uneven bulges in both the splice top cover and the screws protruding through the plates on the underside of the belt. Not only does this weaken the splice, but the screws damage the conveyor components with every revolution.

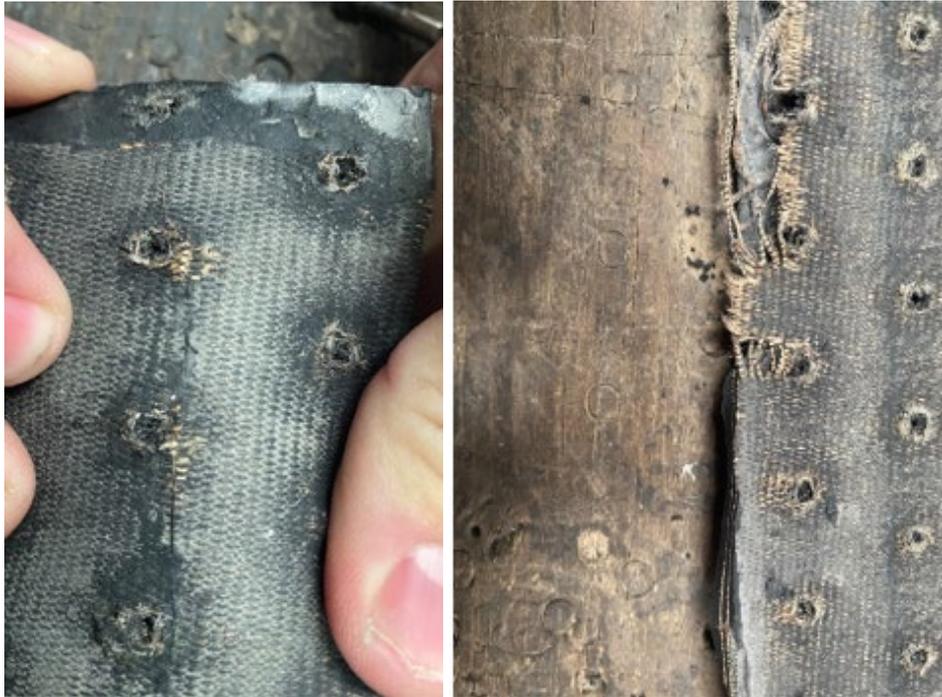
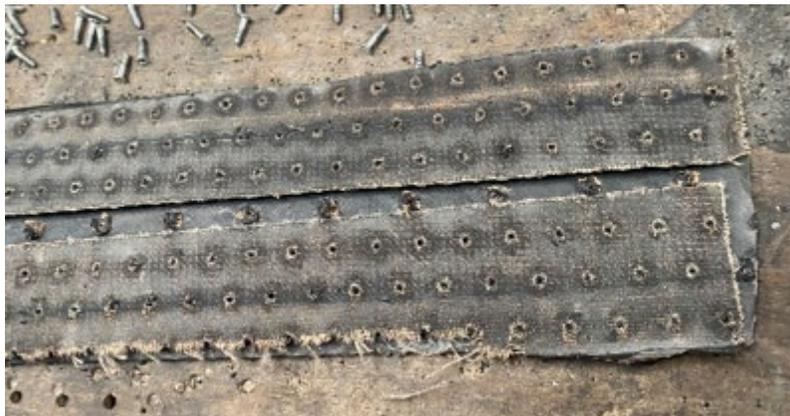
- Plies were cut or damaged when skiving the belt.

Skiving must be done with care. The most damaging discovery made in this evaluation was the damage to the plies holding the splice together. If the fabric is cut during installation, there is nothing to bind the two edges of belt. The pictures depicting the failure show the result of damaged plies; the belt hanging in two pieces. Note the clean cut just prior to the ply tearing in the below picture.

Two other issues of note, the gap between the belt edges is too large, the center screws have nothing to grab on to. The belt is not properly aligned from left to right. This would result in a crooked splice and a challenge to keep the belt running true.

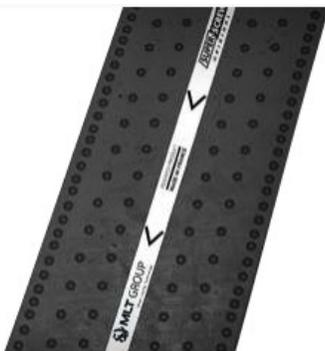
The historical product

Permanent solution

Abrasion resistant (50 mm<sup>2</sup>) | Heat resistant | Fire resistant | Oil resistant | Heat retardant | Very low temperature

Type	Thickness of the splice	
	Top	Bottom
85	7.5 mm (5/16")	4.5 mm (3/16")
100	7.5 mm (5/16")	4.5 mm (3/16")
105	9 mm (3 1/8")	4.5 mm (3/16")

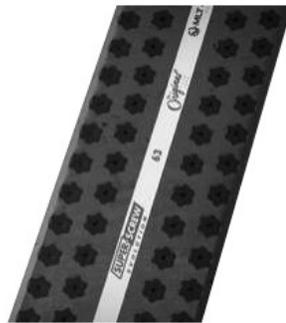
The new generation

Permanent solution

Abrasion resistant (50 mm<sup>2</sup>) | Heat resistant | Fire resistant | Oil resistant | Heat retardant | Very low temperature | Food white

Type	Thickness of the splice	
	Top	Bottom
35	3.5 mm (1/8")	3 mm (1/8")
50	4 mm (1/8")	3 mm (1/8")
63	6 mm (1/4")	3 mm (1/8")
80	6 mm (1/4")	4.7 mm (3/16")

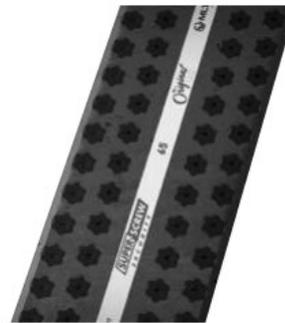
The security (Security indicator)

Permanent solution

Abrasion resistant (50 mm<sup>2</sup>) | Heat resistant | Fire resistant | Oil resistant | Heat retardant | Very low temperature

Type	Thickness of the splice	
	Top	Bottom
65	6 mm (1/4")	3 mm (1/8")
85	8 mm (5/16")	4.7 mm (3/16")
100	8 mm (5/16")	4.7 mm (3/16")
105	10 mm (5/16")	4.7 mm (3/16")

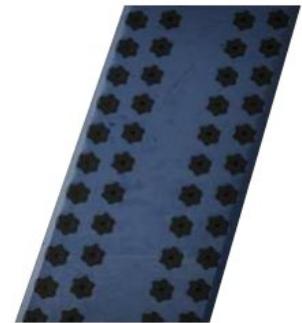
High performance (Polyurethane)
